Manhole Inspection Summary

Manhole # S33WW1004MH

Location Address: **213 TUNBRIDGE RD**

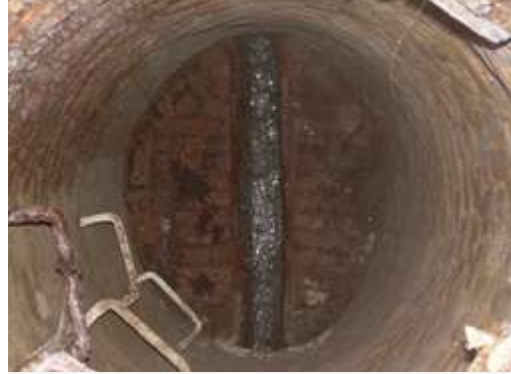
Top View

Corroded steps. Bench debris.

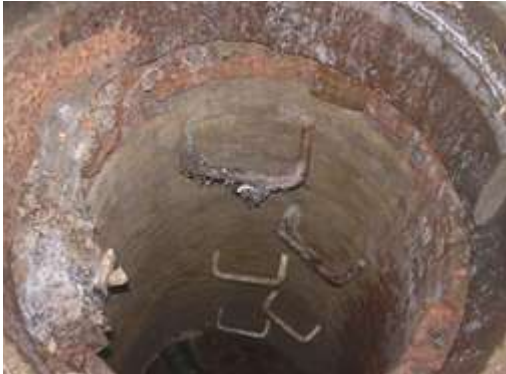
Defect

Frame leaks. Frame offset. Adjustment deterioration, loose brick and infiltration - other side.

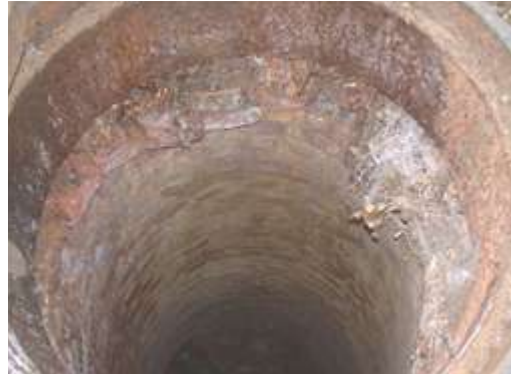
Defect

Frame leaks. Frame offset. Adjustment deterioration, loose brick and infiltration.

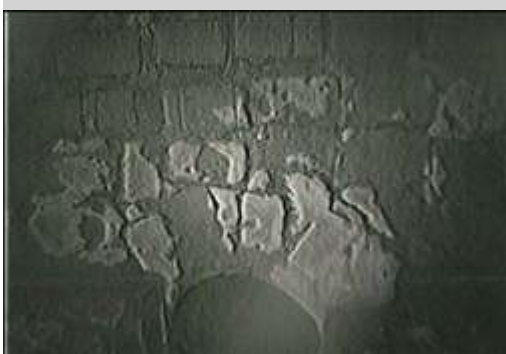
Defect

Barrel infiltration.

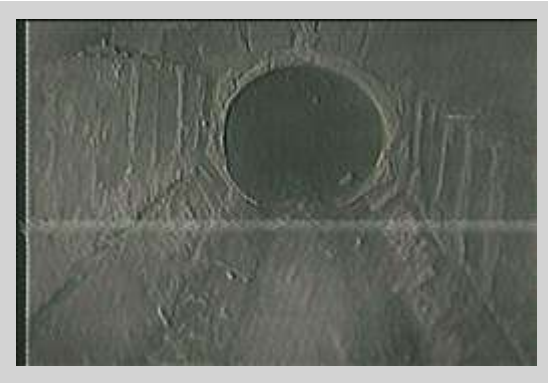
8 in. Circular Gravity Sewer Pipe Out @ 12 O'Clock

Channel deterioration.

Infiltration: **None** Pipe Seal Cond: **Cracked**
